Arboricultural Appraisal Report

Subsidence Damage Investigation at:

Initial Technical Report

Addendum Technical Report

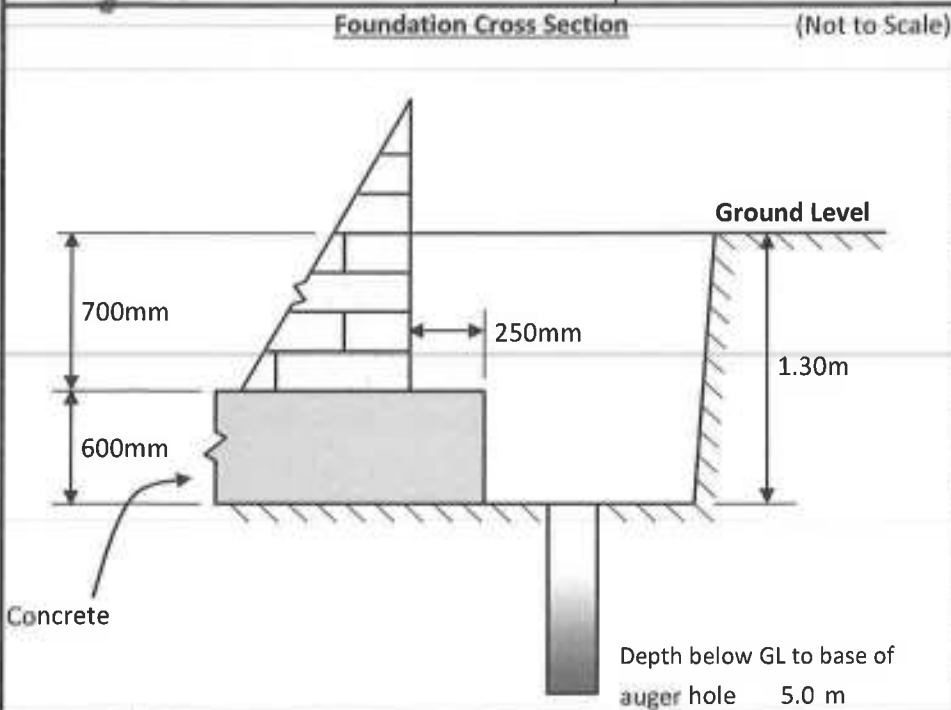
FOUNDATION RECORD

Location: **Front Left Hand Corner of Property** E/H No. **1**
 Ground Surface: **Dry** Weather: **Dry** Date: **07-Sep-16**

Roots Depth & Dia:
 Down to 3.5m
 up to 1mm diameter

Water Depth Hit & Rise:
 None observed on site

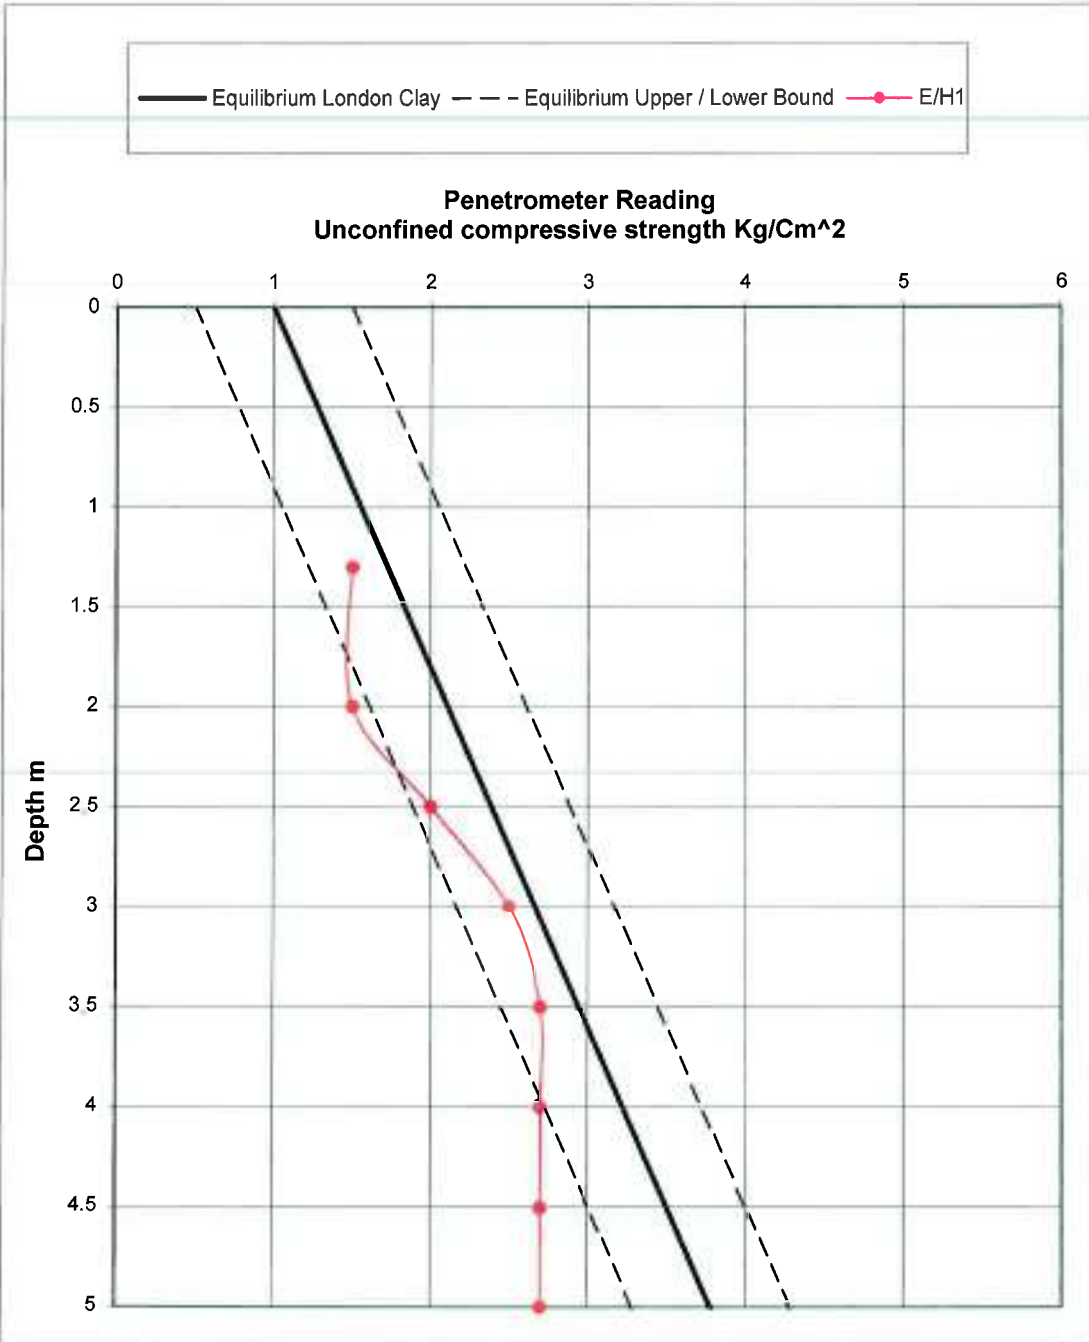
PENETROMETER PLOT

E/H No	Location
E/H1	Front Left Hand Corner of Property

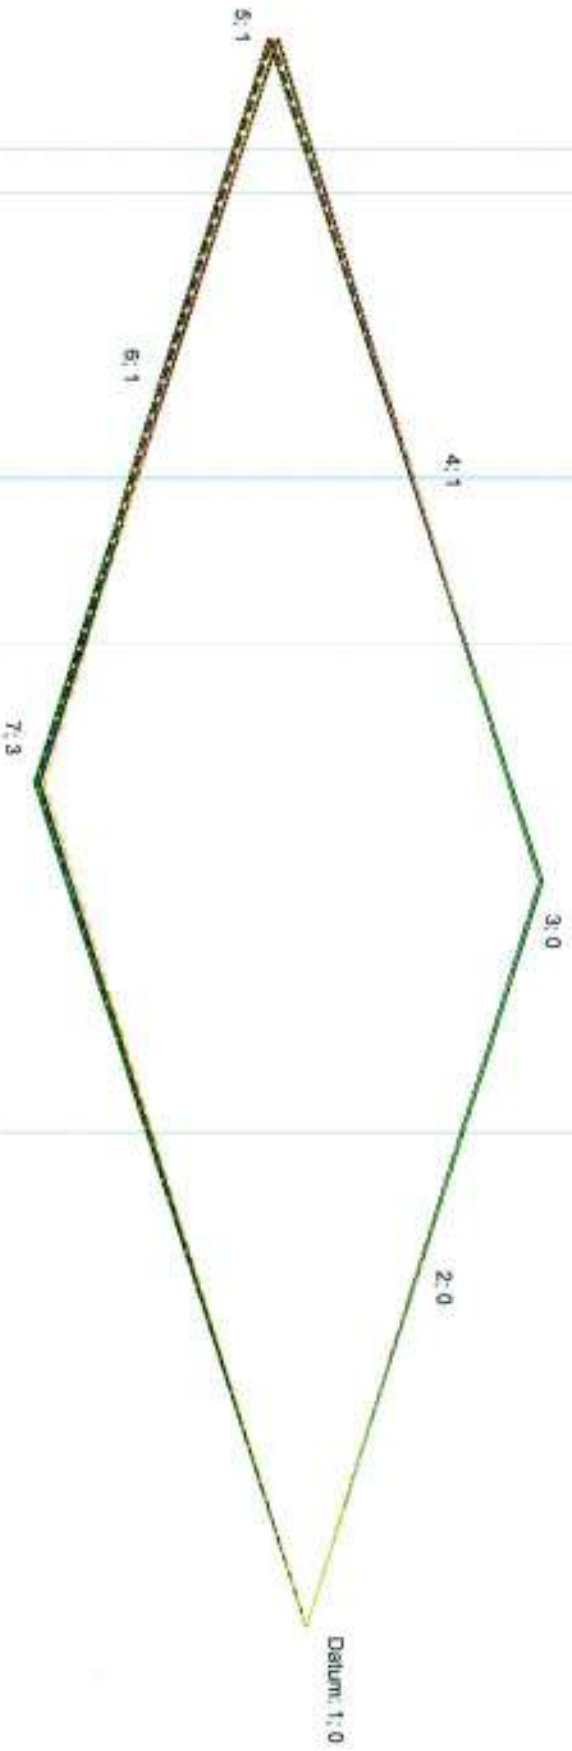
LEVEL MONITORING - RELATIVE MOVEMENT SKETCH

- 07/02/2018
- [REDACTED]
- All stations have been installed within the same brick course. Therefore initial readings can be interpreted as Distortion Data
- there were no suitable drains to use as a datum, therefore readings have been made relative to Level Station 1. It has an assumed value of 10.0000m. If this is not appropriate, please advise if a deep datum is required?
- Further readings planned for Mar'18
