Arboricultural Appraisal Report

Subsidence Damage Investigation at:

Initial Technical Report

Addendum Technical Report

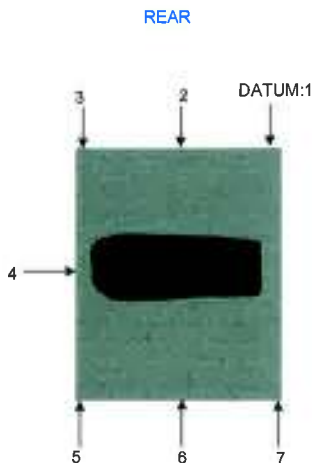
LEVEL MONITORING - RELATIVE MOVEMENT SKETCH

- 07/02/2018
- [REDACTED]
- All stations have been installed within the same brick course. Therefore initial readings can be interpreted as Distortion Data
- there were no suitable drains to use as a datum, therefore readings have been made relative to Level Station 1. It has an assumed value of 10.0000m. If this is not appropriate, please advise if a deep datum is required?
- Further readings planned for Mar'18
